**Flood Control Project Maintenance
Levee Inspections**

Fall 2016 Levee Maintenance Deficiency Summary Report

Sacramento River Basin

Sutter Maintenance Yard Maintenance Area 0001

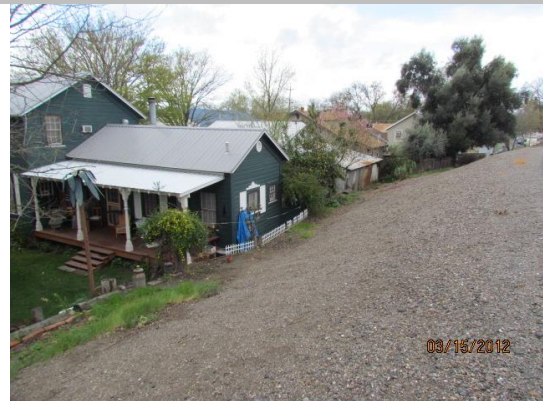
Photo 1 of 1 : FA_2016_MA0001_297_2_20160823_00001.jpg

View of the building along the landside toe.

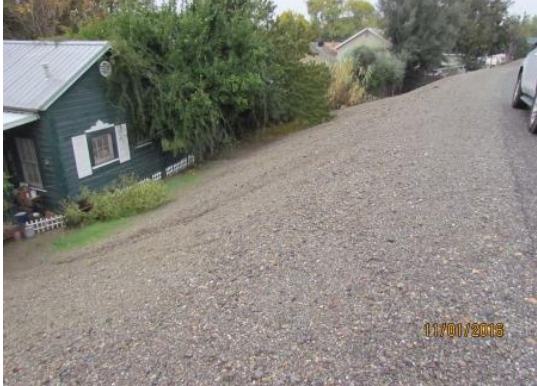
Photo 1 of 1 : FA_2016_MA0001_297_94_20161104_00152.jpg

View of the slope instability along the landside slope.

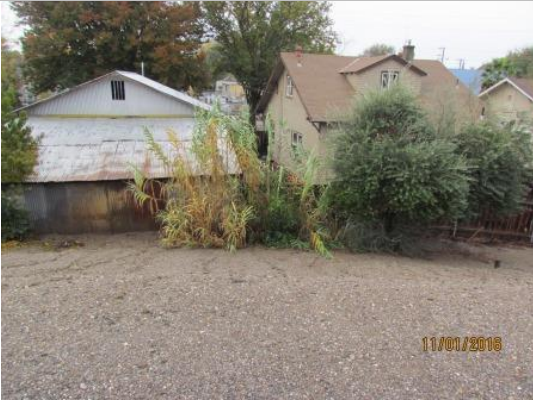
Photo 1 of 1 : FA_2016_MA0001_297_95_20161104_00153.jpg

View of the arundo along the landside toe.

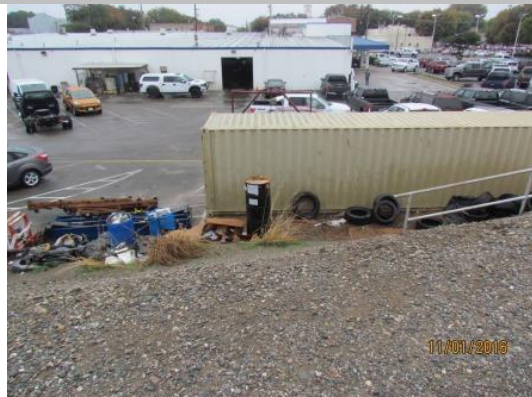
Photo 1 of 1 : FA_2016_MA0001_297_99_20161104_00156.jpg

LM Start	0.42	Rating **	M	Issue No.	99
LM End	0.42	Issue Type +	En	Location *	LS
Category	Earthen Levee			GPS Latitude/Longitude	
				Start	End
Item	Encroachments			39.215863 °	39.215863 °
				-122.008015 °	-122.008015 °
DWR ID	DWR_MA0001_01_f_2016_99				
Comment Code					
EQ : Equipment					
Inspector Comment					
Move the equipment and container at least 10' away from the landside toe.

View of the equipment and shipping container along the landside toe.

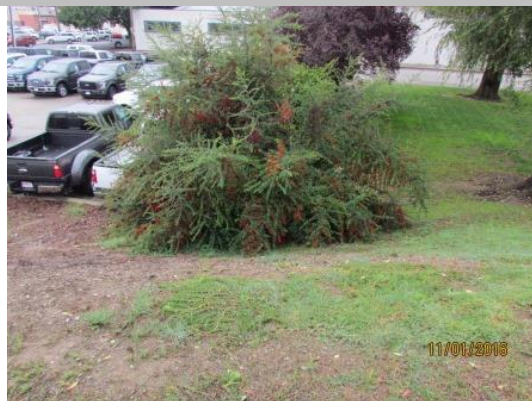
Photo 1 of 1 : FA_2016_MA0001_297_100_20161104_00157.jpg

LM Start	0.49	Rating **	M	Issue No.	100
LM End	0.49	Issue Type +	Ma	Location *	LS
Category	Earthen Levee			GPS Latitude/Longitude	
				Start	End
Item	Trim / Thin Trees			39.215800 °	39.215800 °
				-122.009402 °	-122.009402 °
DWR ID	DWR_MA0001_01_f_2016_100				
Comment Code					
T1 : Trim trees to at least five feet above ground level.					
Inspector Comment

View of an overgrown bush obstructing visibility.

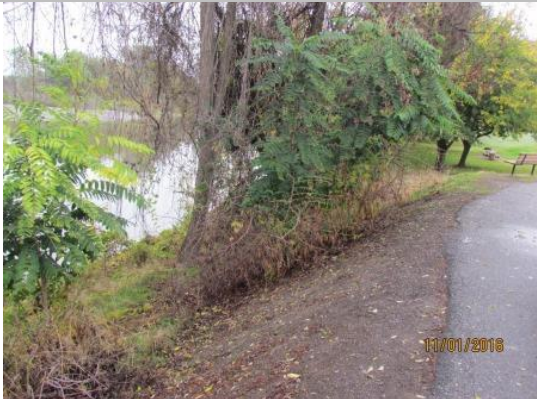
Photo 1 of 1 : FA_2016_MA0001_297_102_20161104_00158.jpg

View of a tree obstructing visibility and access.

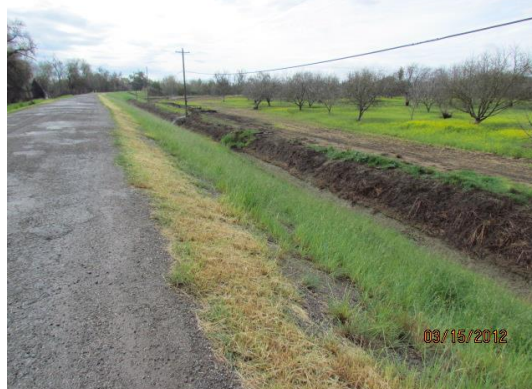
Photo 1 of 1 : FA_2016_MA0001_297_6_20160823_00004.jpg

LM Start	1.20	Rating **	U	Issue No.	6
LM End	1.34	Issue Type +	En	Location *	LS
Category	Earthen Levee			GPS Latitude/Longitude	
				Start	End
Item	Encroachments			39.222119 °	39.224063 °
				-122.015747 °	-122.016080 °
DWR ID	DWR_MA0001_01_s_2012_6				
Comment Code					
DT : Ditch					
Inspector Comment

View of an ag ditch along the landside toe.

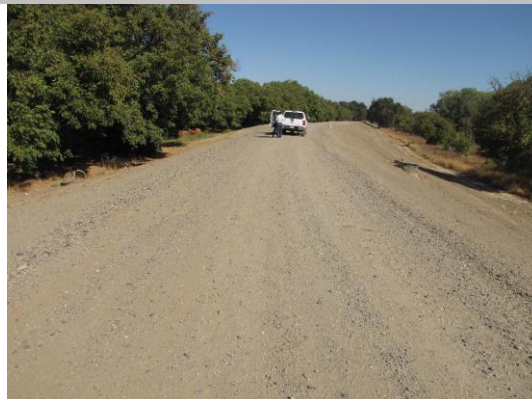
Photo 1 of 2 : UCIP_FA_2016_50466_70071.jpg

FS_ID:50466
DS_ID:17565
EP_NO: 9487
Repair Type: Non-Urgent
Crossing Status: Found
UCIP Comments: 10/24/2016 Ws pipe end still plugged.(DWR Sutter Yard- AFreitag)4/25/2016 WS pipe end still plugged with soil. rest of pipe appears in good condition.4/20/2015 WS pipe end plugged about 50% by soil.6/18/2014 Same as last inspection.12/17/2013 Same as last inspection.7/18/2013 WS pipe end has been reformed but is still partially blocked with dirt and debris.10/18/2012 WS-remove dirt and debris in riser. Outlet deformed and blocked over 50%. Burrow activity near outlet on waterward slope. Debris around concrete section on landward side. This crossing was listed in the USACE Periodic Inspections as ID# USACE_CESPK_MA1C_2010_p_0116 for crossing outlet deformed and clogged with dirt.
FIELD_STRUCT_DESC: 2 of 2: 36-inch corrugated metal drainage pipe through the levee, approximately 12-15 feet below the crown. Slide gates in corrugated metal pipe (CMP) riser on the waterside (WS) slope. Pipe daylights on the landside (LS). (Automatic Board Order (ABO) issued as Permit No. 9487, 1974 - Jimeno Rancho) [Additional Reference(s): DWR Levee Log, 1992. USACE Sacramento O&M Manual 137, August 1955, (Station 103+18)].

View of levee crown and slopes looking upstream at crossing.

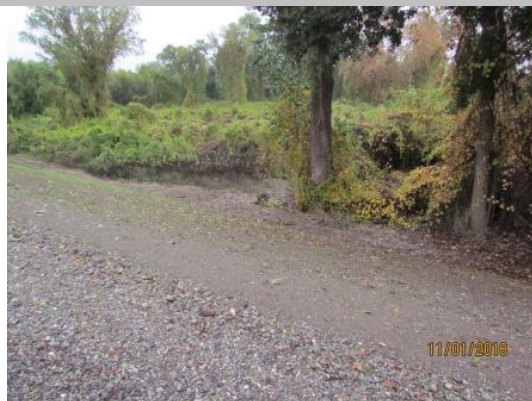
Photo 1 of 2 : FA_2016_MA0001_297_105_20161104_00162.jpg

LM Start	2.16	Rating **	M	Issue No.	105
LM End	2.16	Issue Type +	Ma	Location *	WS
Category	Earthen Levee			GPS Latitude/Longitude	
				Start	End
Item	Erosion / Bank Caving			39.235107°	39.235107°
				-122.013567°	-122.013567°
DWR ID	DWR_MA0001_01_f_2016_105				
Comment Code					
E2 : Schedule repair of erosion site prior to the next inspection.					
Inspector Comment

View of an erosion site along the waterside berm.

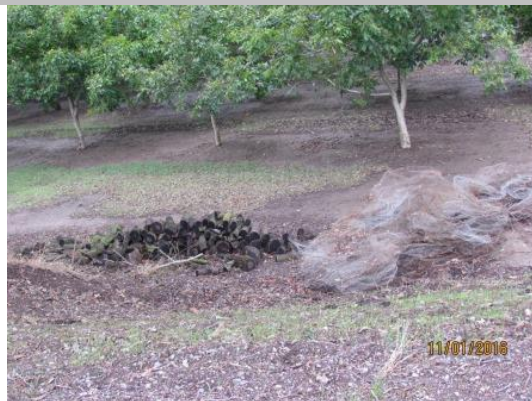
Photo 1 of 1 : FA_2016_MA0001_297_106_20161104_00164.jpg

LM Start	2.23	Rating **	M	Issue No.	106
LM End	2.23	Issue Type +	En	Location *	LS
Category	Earthen Levee			GPS Latitude/Longitude	
				Start	End
Item	Encroachments			39.235880 °	39.235880 °
				-122.013045 °	-122.013045 °
DWR ID	DWR_MA0001_01_f_2016_106				
Comment Code					
FW : Firewood					
Inspector Comment					
Remove the chicken wire and firewood from the landside toe.

View of the firewood along the landside toe.

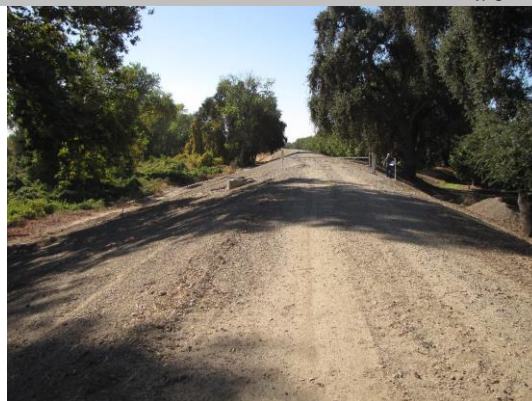
Photo 1 of 2 : UCIP_FA_2016_50467_70078.jpg

FS_ID:50467
DS_ID:16429
EP_NO: 9472
Repair Type: Non-Urgent
Crossing Status: Found
UCIP Comments: 10/24/2016 Debris still inside of riser.(DWR Sutter Yard- AFreitag)4/25/2016 Pipe still inside of riser and LS end plugged about 50% by soil.4/20/2015 Same as last inspection.6/18/2014 Same as last inspection.12/17/2013 Same as last inspection.7/18/2013 Same as last inspection.10/18/12 Remove debris from riser. Landward inlet is blocked by over 50%. This crossing was listed in the USACE Periodic Inspections as ID# USACE_CESPK_MA1C_2010_p_0128 for sediment build up at inlet (landward side) and debris inside riser.
FIELD_STRUCT_DESC: 54-inch corrugated metal drainage pipe through the levee, approximately 12-15 feet below the crown. Slide gate in corrugated metal pipe (CMP) riser on the waterside (WS) slope. 48-inch CMP at landside (LS) slope. This crossing crosses the levee at an angle. (Automatic Board Order (ABO) issued as Permit No. 9472, 1974 - Ballard) [Additional Reference(s): DWR Levee Log, 1992. USACE Sacramento O&M Manual 137, August 1955, (Station 120+00)].

View of levee crown looking downstream at crossing. CMP riser located on WS shoulder.

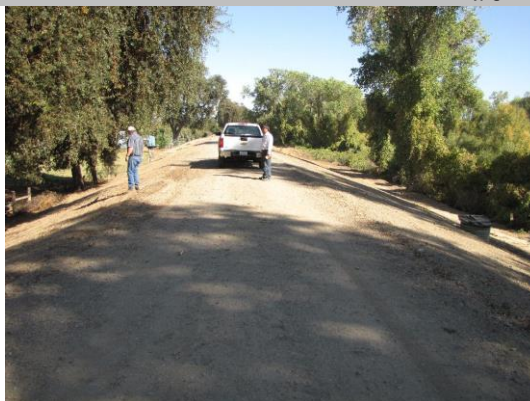
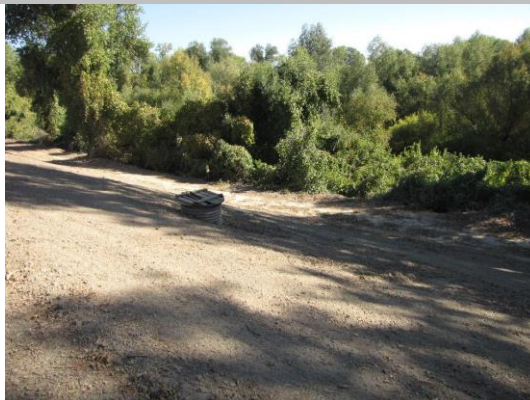
FS_ID:50468
DS_ID:16428
EP_NO: 9467
Repair Type: Non-Urgent
Crossing Status: Found
UCIP Comments: 10/24/2016 Abandoned.(DWR Sutter Yard-AFreitag)4/25/2016 Abandoned crossing. Unable to locate any WS and LS pipe ends.4/20/2015 Same as last inspection.6/18/2014 Same as last inspection.12/17/2013 Same as last inspection.7/18/2013 Same as last inspection.10/18/2012 Only riser visible. Debris and sediment blocking gate. Gate inside riser is buried and non-functional. If crossing is abandoned, owner needs to properly abandon. This crossing was listed in the USACE Periodic Inspections as ID# USACE_CESPK_MA1C_2010_p_0132 no culvert through the levee is visible here.
FIELD_STRUCT_DESC: *ABANDONED* 24-inch corrugated metal drainage pipe through the levee, approximately 12-15 feet below the crown. Slide gate in CM pipe riser on the waterside (WS) slope. No signs of inlet visible on the landside (LS). (Automatic Board Order (ABO) issued as Permit No. 9467, 1974 - Lovell E. Spurgeon)

Overview of levee crown looking upstream at crossing.

View of WS slope and toe.

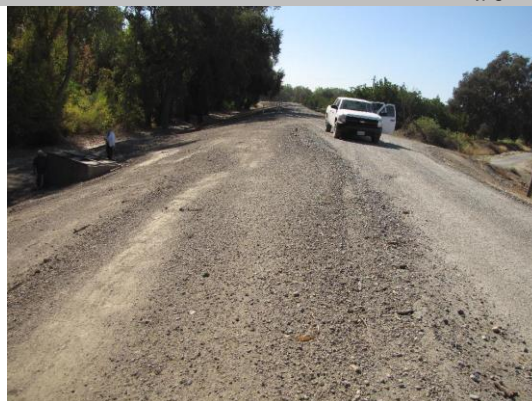
Photo 1 of 2 : UCIP_FA_2016_50471_70105.jpg

FIELD_STRUCT_DESC: 2 of 2: 60-inch reinforced concrete irrigation pipe through the levee, approximately 12-15 feet below the crown. Crossing goes through the levee at an angle. Slide gates in concrete well at the waterside (WS) toe. Slide gate missing. (Automatic Board Order (ABO) issued as Permit No. 9474, 1974 - George R. Zumwalt) O&M manual description is for two 5-foot by 5-foot concrete culverts with two hand operated slide gates. Culvert constructed with wing walls and gate well. [Additional Reference(s): DWR Levee Log, 1992. USACE Sacramento O&M Manual 137, August 1955, (Station 150+06)].
FS Date: 10/27/2016 9:12:30 AM

Overview of levee crown looking downstream at crossing.

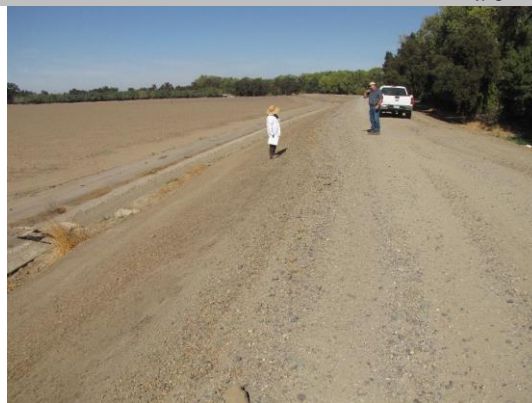
Photo 1 of 2 : UCIP_FA_2016_50473_70110.jpg

Comment Code					
Inspector Comment					
FS_ID:50473 DS_ID:16426 EP_NO: 9490 Repair Type: Non-Urgent Crossing Status: Found UCIP Comments: 10/24/2016 WS slide gate stem is still bent.(DWR Sutter Yard- A Freitag)4/25/2016 WS slide gate is slightly bent. Rest of crossing appears to be in good condition. 4/20/2015 LS inlet still has some minor sediment build up. Needs to be cleaned.6/18/2014 Same as last inspection.12/17/2013 Same as last inspection.7/18/2013 WS slide gate looks to be in good condition but stem is slightly bent. Not sure if bend will hinder gates operation or not. LS inlet is still blocked by minor sediment build up.10/18/2012 LS pipe slightly deformed and sediment build up blocking about 30% of opening; need to check the condition of the slide gate-need photo. Metal marker down. This crossing was listed in the USACE Periodic Inspection as ID# USACE_CESPK_MA1C_2010_p_0187 for sediment build up at landward toe. FIELD_STRUCT_DESC: 36-inch corrugated metal drainage pipe through the levee, approximately 12-15 feet below the crown. Slide gate in corrugated metal pipe (CMP) riser on the waterside (WS) slope. (Permit No. 9490, 1955 - Charles & Virginia Yerxa) [Additional Reference(s): DWR Levee Log, 1992. USACE Sacramento O&M Manual 137, August 1955, (Station 177+67)]. FS Date: 10/27/2016 9:13:51 AM

View of LS looking upstream.

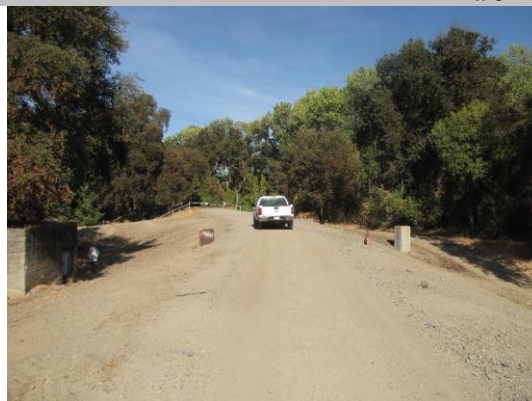
Photo 1 of 2 : UCIP_FA_2016_50474_70222.jpg

Overview of levee crown looking upstream at crossing.

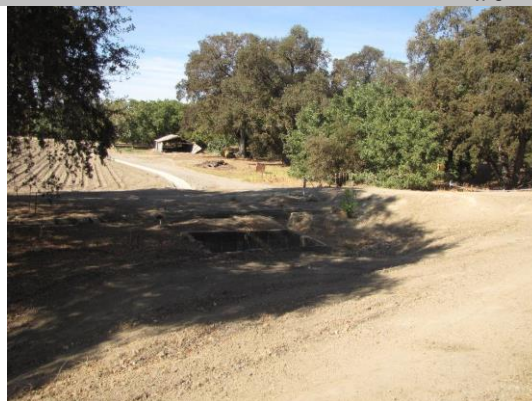
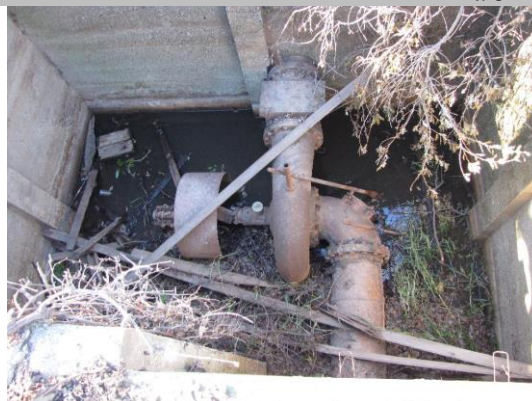
Concrete distribution box located on LS.

Abandoned pump system inside concrete structure located on LS.

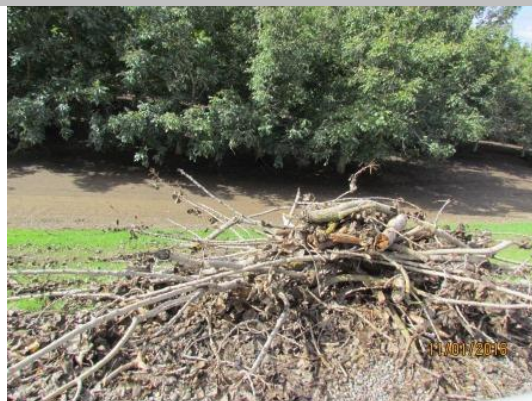
Photo 1 of 1 : FA_2016_MA0001_297_111_20161104_00169.jpg

LM Start	3.74	Rating **	M	Issue No.	111
LM End	3.74	Issue Type +	En	Location *	LS
Category	Earthen Levee			GPS Latitude/Longitude	
				Start	End
Item	Encroachments			39.256533 °	39.256533 °
				-122.010262 °	-122.010262 °
DWR ID	DWR_MA0001_01_f_2016_111				
Comment Code					
PR : Prunings					
Inspector Comment					
Remove prunings from the landside toe.

View of the prunings along the landside toe.

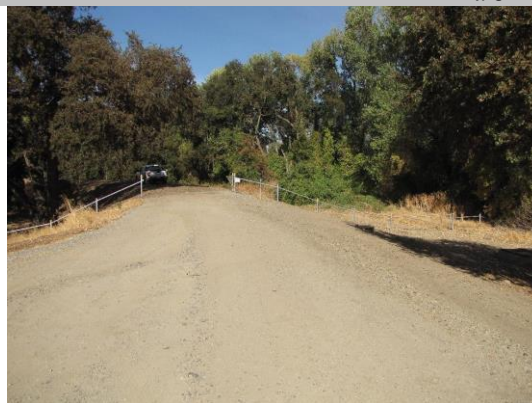
Photo 1 of 2 : UCIP_FA_2016_50476_70128.jpg

Comment Code					
Inspector Comment					
FS_ID:50476 DS_ID:16423 EP_NO: 9489 Repair Type: Non-Urgent Crossing Status: Found UCIP Comments: 10/24/2016 Crossing appears abandoned.(DWR Sutter Yard- AFreitag)4/25/2016 Crossing appears abandoned and should be abandoned properly.4/20/2015 Same as last inspection.6/18/2014 Same as last inspection.12/17/2013 Same as last inspection.7/18/2013 Same as last inspection.10/19/2012 Slide gate wheel handle missing. Clear debris from CMP riser. This crossing was listed in the USACE Periodic Inspection as ID# USACE_CESPK_MA1C_2010_p_0196 for access box contains backfilled (permanently shut) and outlet located on landside has sediment build up. FIELD_STRUCT_DESC: 36-inch corrugated metal irrigation pipe through the levee at an unknown depth below the crown. Slide gate in corrugated metal pipe (CMP) riser on the waterside (WS) slope. 6-foot by 6-foot concrete box on the WS berm. Additional 12-inch pipe inside concrete distribution box. (Automatic Board Order (ABO) issued as Permit No. 9489, 1974 - Mayfair Farms Inc.) [Additional Reference(s): DWR Levee Log, 1992. USACE Sacramento O&M Manual 137, August 1955, (Station 198+00)]. FS Date: 10/27/2016 9:24:08 AM

View of crossing looking upstream. Concrete box located on the WS.

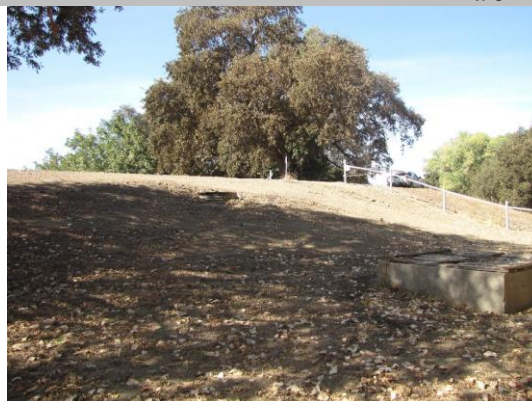
Photo 2 of 2 : UCIP_FA_2016_50476_70131.jpg

Item	DWR UCIP Field Study			39.256203 °	39.256203 °	
				-122.009940 °	-122.009940 °	
DWR ID						
Comment Code						
Inspector Comment						
FS_ID:50476 DS_ID:16423 EP_NO: 9489 Repair Type: Non-Urgent Crossing Status: Found UCIP Comments: 10/24/2016 Crossing appears abandoned.(DWR Sutter Yard- A Freitag)4/25/2016 Crossing appears abandoned and should be abandoned properly.4/20/2015 Same as last inspection.6/18/2014 Same as last inspection.12/17/2013 Same as last inspection.7/18/2013 Same as last inspection.10/19/2012 Slide gate wheel handle missing. Clear debris from CMP riser. This crossing was listed in the USACE Periodic Inspection as ID# USACE_CESPK_MA1C_2010_p_0196 for access box contains backfilled (permanently shut) and outlet located on landside has sediment build up. FIELD_STRUCT_DESC: 36-inch corrugated metal irrigation pipe through the levee at an unknown depth below the crown. Slide gate in corrugated metal pipe (CMP) riser on the waterside (WS) slope. 6-foot by 6-foot concrete box on the WS berm. Additional 12-inch pipe inside concrete distribution box. (Automatic Board Order (ABO) issued as Permit No. 9489, 1974 - Mayfair Farms Inc.) [Additional Reference(s): DWR Levee Log, 1992. USACE Sacramento O&M Manual 137, August 1955, (Station 198+00)]. FS Date: 10/27/2016 9:24:08 AM

View of concrete distribution box and CMP riser located on WS.

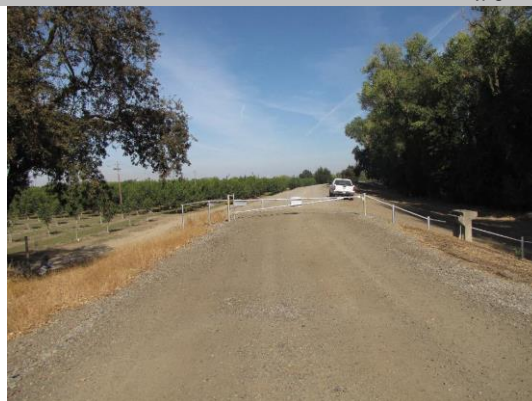
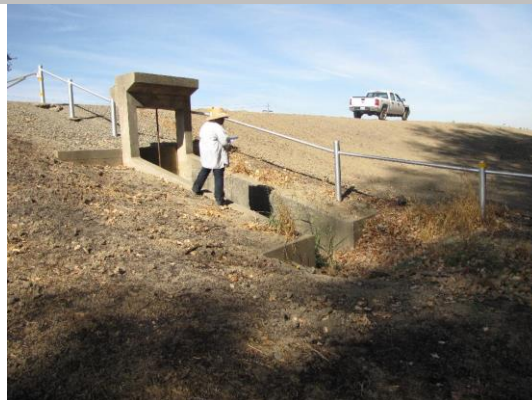
View of levee crown looking upstream at crossing.

View of WS slope with concrete structure.

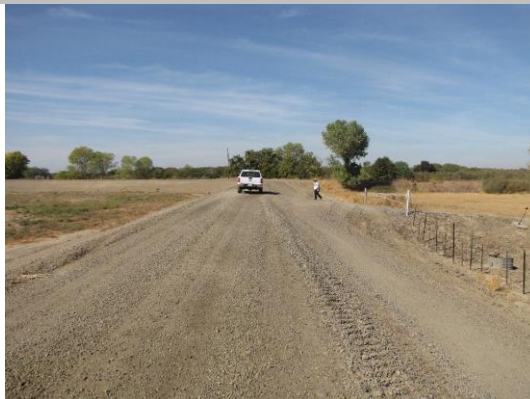
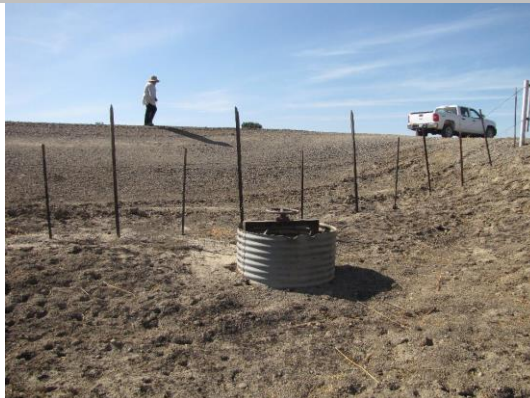
Overview of levee crown looking upstream at crossing.

Riser with slide gate located on WS toe.

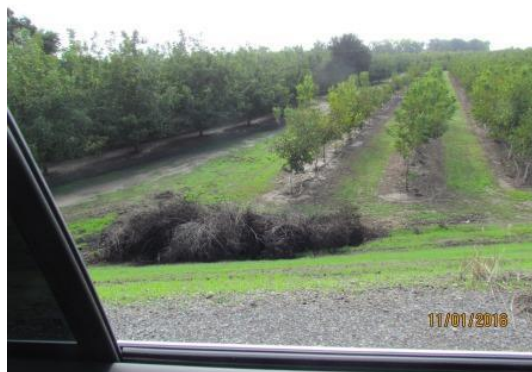
Photo 1 of 1 : FA_2016_MA0001_297_112_20161104_00170.jpg

LM Start	4.85	Rating **	M	Issue No.	112
LM End	4.85	Issue Type +	En	Location *	LS
Category	Earthen Levee			GPS Latitude/Longitude	
				Start	End
Item	Encroachments			39.265738 °	39.265738 °
				-122.013880 °	-122.013880 °
DWR ID	DWR_MA0001_01_f_2016_112				
Comment Code					
PR : Prunings					
Inspector Comment					
Remove prunings from the landside toe.

View of the prunings along the landside toe.

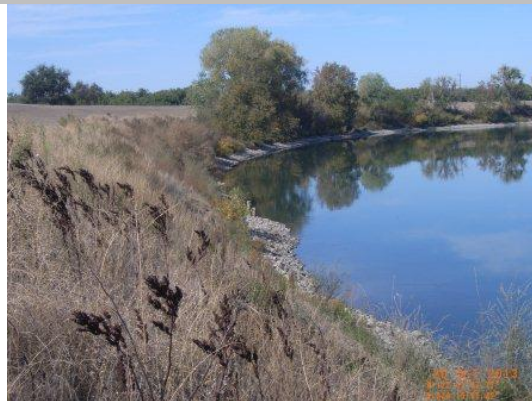
Photo 1 of 1 : FA_2016_MA0001_297_3_20160823_00002.jpg

LM Start	4.86	Rating **	M	Issue No.	3
LM End	5.26	Issue Type +	Ma	Location *	WS
Category	Supplemental			GPS Latitude/Longitude	
				Start	End
Item	2015 USACE Erosion Survey, DRAFT			39.265730 °	39.266315 °
				-122.014925 °	-122.020682 °
DWR ID	DWR_MA0001_01_s_2016_3				
Comment Code					
Inspector Comment					
2009 - Slump in the middle of the section has left a vertical section on the bank. 2010 - Old cobble site unraveling, site extended downstream. 2015: Last observed in 2013. [2015 Site ID: SAC_151-0_R]

USACE 2013 Photo #1

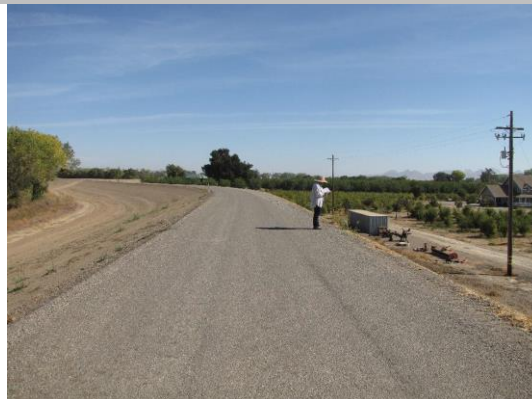
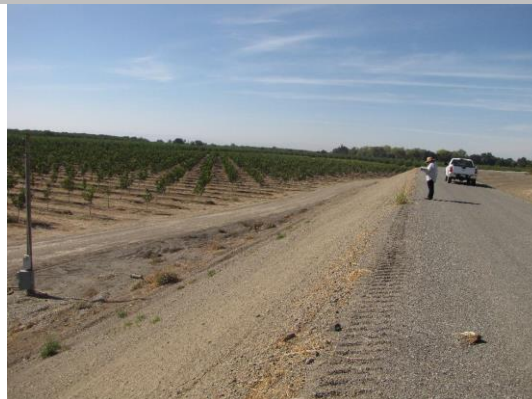
View of levee crown looking downstream at crossing.

View of levee crown looking upstream at crossing.

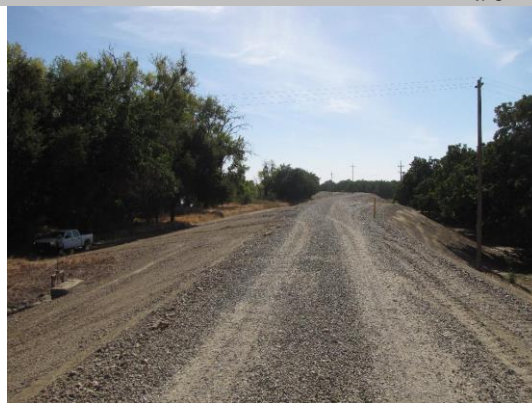
Photo 1 of 2 : UCIP_FA_2016_50481_70154.jpg

Comment Code					
Inspector Comment					
FS_ID:50481 DS_ID:16419 EP_NO: 9476 Repair Type: Non-Urgent Crossing Status: Found UCIP Comments: 10/24/2016 LS outlets becoming over grown with vegetation in the ditch.(DWR Sutter Yard- A Freitag)4/25/2016 WS entry still blocked and wingwalls still cracked.4/20/2015 WS entry still blocked and wingwalls still cracked.6/18/2014 Same as last inspection.12/17/2013 Same as last inspection.7/18/2013 Same as last inspection.10/19/2012 blocked, no entry on WS. This crossing was listed in the USACE Periodic Inspection as ID# USACE_CESPK_MA1C_2010_p_0247 for u/s and d/s wing wall shows some cracking and tilting. FIELD_STRUCT_DESC: 1 of 2: 36-inch corrugated metal irrigation pipe and concrete box culvert through the levee at an unknown depth below the crown. Concrete headwall visible on the landside (LS) toe. (Automatic Board Order (ABO) issued as Permit No. 9476, 1974 - Ohliger) [Additional Reference(s): DWR Levee Log, 1992]. FS Date: 10/27/2016 12:45:51 PM

Overview of levee crown looking downstream at crossing.

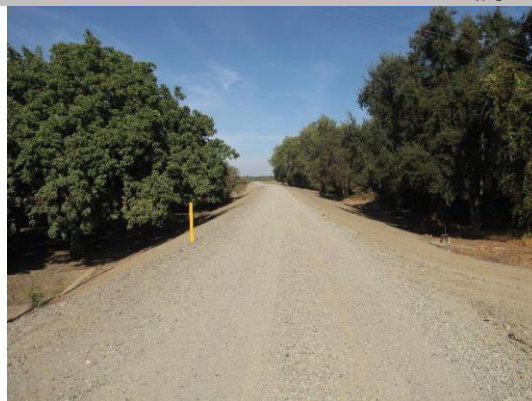
Photo 2 of 2 : UCIP_FA_2016_50481_70152.jpg

Item	DWR UCIP Field Study			39.272069 °	39.272069 °	
				-122.023240 °	-122.023240 °	
DWR ID						
Comment Code						
Inspector Comment						
FS_ID:50481 DS_ID:16419 EP_NO: 9476 Repair Type: Non-Urgent Crossing Status: Found UCIP Comments: 10/24/2016 LS outlets becoming over grown with vegetation in the ditch.(DWR Sutter Yard- A Freitag)4/25/2016 WS entry still blocked and wingwalls still cracked.4/20/2015 WS entry still blocked and wingwalls still cracked.6/18/2014 Same as last inspection.12/17/2013 Same as last inspection.7/18/2013 Same as last inspection.10/19/2012 blocked, no entry on WS. This crossing was listed in the USACE Periodic Inspection as ID# USACE_CESPK_MA1C_2010_p_0247 for u/s and d/s wing wall shows some cracking and tilting. FIELD_STRUCT_DESC: 1 of 2: 36-inch corrugated metal irrigation pipe and concrete box culvert through the levee at an unknown depth below the crown. Concrete headwall visible on the landside (LS) toe. (Automatic Board Order (ABO) issued as Permit No. 9476, 1974 - Ohliger) [Additional Reference(s): DWR Levee Log, 1992]. FS Date: 10/27/2016 12:45:51 PM

View of crossing looking upstream at crossing.

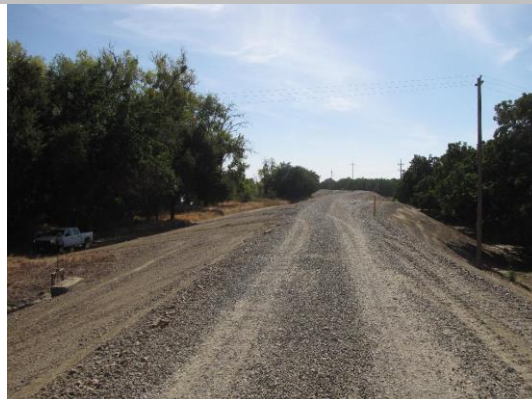
Photo 1 of 2 : UCIP_FA_2016_50482_70162.jpg

Comment Code					
Inspector Comment					
FS_ID:50482 DS_ID:17569 EP_NO: 9476 Repair Type: Non-Urgent Crossing Status: Found UCIP Comments: 10/24/2016 LS outlets becoming overgrown with vegetation in the dtch.(DWR Sutter Yard- AFreitag)4/25/2016 WS entry still blocked and wingwalls still cracked.4/20/2015 WS entry still blocked and wingwalls still cracked.6/18/2014 Same as last inspection.12/17/2013 Same as last inspection.7/18/2013 Same as last inspection.10/19/2012 blocked, no entry on WS. This crossing was listed in the USACE Periodic Inspection as ID# USACE_CESPK_MA1C_2010_p_0247 for u/s and d/s wing wall shows some cracking and tilting. FIELD_STRUCT_DESC: 2 of 2: 36-inch corrugated metal irrigation pipe (15 feet long) and concrete box culvert through the levee at an unknown depth below the crown. Slide gate located on the waterside (WS). Concrete headwall visible on the landside (LS) toe. (Automatic Board Order (ABO) issued as Permit No. 9476-1974, Howard C. & Nadine M. Ohliger) [Additional Reference(s): DWR Levee Log, 1992]. FS Date: 10/27/2016 12:47:15 PM

View of levee crown looking downstream at crossing.

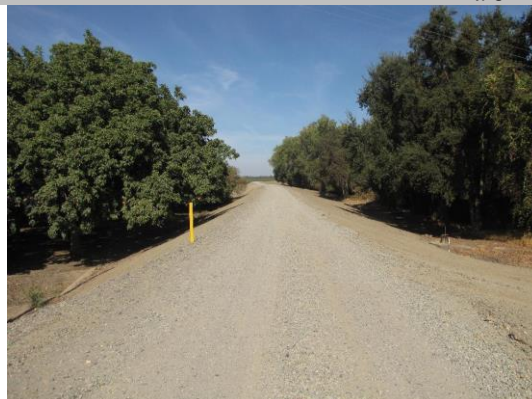
Photo 2 of 2 : UCIP_FA_2016_50482_70161.jpg

View of levee crown looking upstream at crossing.

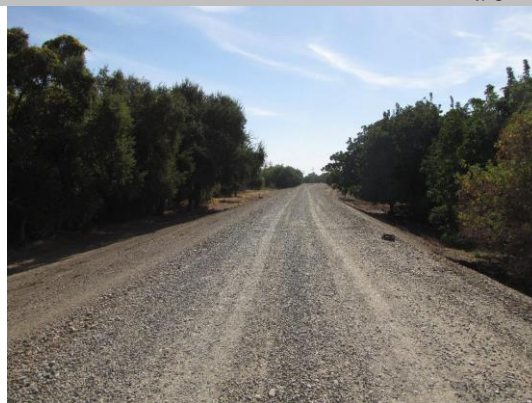
Photo 1 of 2 : UCIP_FA_2016_50484_70167.jpg

Comment Code					
Inspector Comment					
FS_ID:50484 DS_ID:16418 EP_NO: 6263 Repair Type: Non-Urgent Crossing Status: Found UCIP Comments: 10/24/2016 Appears to be in good condition.(DWR Sutter Yard- A Freitag)4/25/2016 Pressure gauge and valve were added to pipe near the siphon breaker on LS shoulder.4/20/2015 Modifications are being made to pipe near the LS shoulder. Not sure what all exactly is being done.6/23/2014 Same as last inspection. 12/17/2013 Same as last inspection.7/18/2013 Debris cleared from in front of LS standpipe.10/19/2012 Remove debris from landward side see photo 2. This crossing was listed in the USACE Periodic Inspection as ID# USACE_CESPK_MA1C_2010_p_0249 however, unable to determine why crossing was marked "U". FIELD_STRUCT_DESC: 18-inch asphalt coated steel irrigation pipe through the levee, 2 feet below the crown. Siphon breaker on the landside (LS) shoulder. Corrugated metal pipe (CMP) riser located on the LS connects with concrete V-ditch. Dual slant pumps and gate valves on the bank approximately 215 feet from waterside (WS) toe. Pump feeds into single 18-inch steel pipe. 2-inch electrical conduit buried in the same trench as the irrigation pipe. (Permit No. 6263, 1968 - C. Tuttle) [Additional Reference(s): DWR Levee Log, 1992]. FS Date: 10/27/2016 12:48:52 PM

Overview of levee crown looking downstream at crossing.

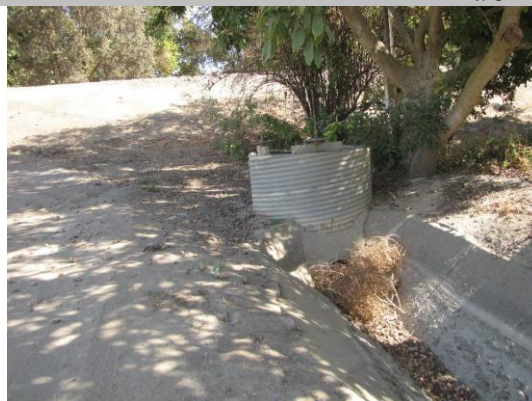
Photo 2 of 2 : UCIP_FA_2016_50484_70166.jpg

FS_ID:50484
DS_ID:16418
EP_NO: 6263
Repair Type: Non-Urgent
Crossing Status: Found
UCIP Comments: 10/24/2016 Appears to be in good condition.(DWR Sutter Yard- AFreitag)4/25/2016 Pressure gauge and valve were added to pipe near the siphon breaker on LS shoulder.4/20/2015 Modifications are being made to pipe near the LS shoulder. Not sure what all exactly is being done.6/23/2014 Same as last inspection.

12/17/2013 Same as last inspection.7/18/2013 Debris cleared from in front of LS standpipe.10/19/2012 Remove debris from landward side see photo 2. This crossing was listed in the USACE Periodic Inspection as ID# USACE_CESPK_MA1C_2010_p_0249 however, unable to determine why crossing was marked "U".
FIELD_STRUCT_DESC: 18-inch asphalt coated steel irrigation pipe through the levee, 2 feet below the crown. Siphon breaker on the landside (LS) shoulder. Corrugated metal pipe (CMP) riser located on the LS connects with concrete V-ditch. Dual slant pumps and gate valves on the bank approximately 215 feet from waterside (WS) toe. Pump feeds into single 18-inch steel pipe. 2-inch electrical conduit buried in the same trench as the irrigation pipe. (Permit No. 6263, 1968 - C. Tuttle) [Additional Reference(s): DWR Levee Log, 1992].
FS Date: 10/27/2016 12:48:52 PM

CMP riser and concrete lined v-ditch located on LS toe.

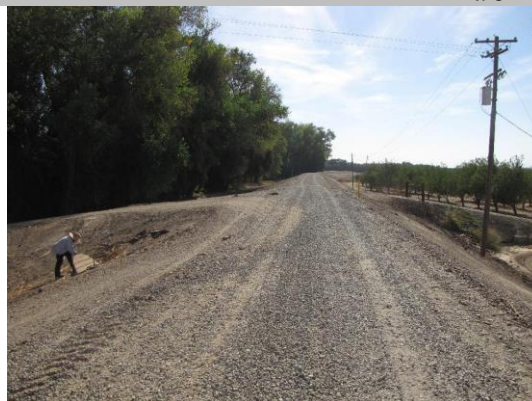
Photo 1 of 2 : UCIP_FA_2016_50485_70174.jpg

FS_ID:50485
DS_ID:16446
EP_NO: N/A
Repair Type: Urgent
Crossing Status: Found
UCIP Comments: 10/24/2016 Pvc was back running through the crossing and blocking the screwgate. photo attached(DWR Sutter Yard- AFreitag)9/28/2016 Crossing has been downgraded from Urgent to Non-Urgent 5-inch PVC pipe was cut to allow the slide gate to close. Need to contact owner to remove unauthorized pipe to comply with Title 23. (DWR UCIP - omagana)4/25/2016 5 inch pvc pipe running through crossing has been cut out to allow the slide gate to close. (DWR Sutter Yard - afreitag)4/20/2015 5inch pvc is still present blocking slide gate from closing. WS end of pipe has been exposed so there is no way to stop water from flowing through pipe during highwater times. (DWR Sutter Yard - afreitag)6/23/2014 Same as last inspection. There is no way to stop water from flowing though pipe during high water times. (DWR Sutter Yard - afreitag)12/17/2013 Same as last inspection. (DWR Sutter Yard - afreitag)7/18/2013 Same as last inspection. (DWR Sutter Yard - afreitag)10/19/2012 Unauthorized 5 inch PVC pipe running through 36 inch crossing. 5 inch PVC crossing prevents slide gate from closing during high water. Debris and sediment inside riser. This crossing was listed in the USACE Periodic Inspection as ID# USACE_CESPK_MA1C_2010_p_0258 for 5 inch PVC pipe running through culvert. (DWR UCIP - omagana) FIELD_STRUCT_DESC: 36-inch steel (not corrugated metal, as referenced in O&M manual) drainage pipe through the levee, approximately 14-16 feet below levee crown. Slide gate in corrugated metal pipe (CMP) riser on the waterside (WS) slope. Pipe also visible on the landside (LS). [Additional Reference(s): DWR Levee Log, 1992. USACE Sacramento O&M Manual 137, August 1955, (Station 331+31)]. FS Date: 10/27/2016 12:49:27 PM

Overview of levee crown looking downstream at crossing.

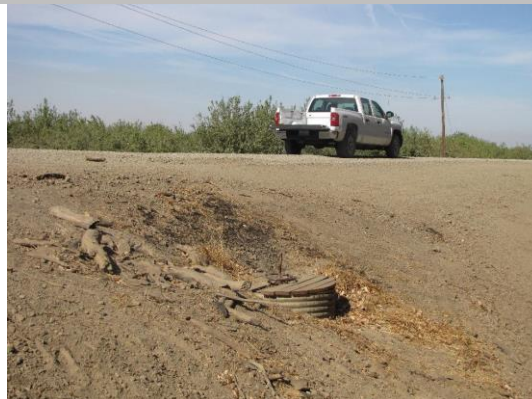
Photo 2 of 2 : UCIP_FA_2016_50485_70176.jpg

FS_ID:50485
DS_ID:16446
EP_NO: N/A
Repair Type: Urgent
Crossing Status: Found
UCIP Comments: 10/24/2016 Pvc was back running through the crossing and blocking the screwgate. photo attached(DWR Sutter Yard- AFreitag)9/28/2016 Crossing has been downgraded from Urgent to Non-Urgent 5-inch PVC pipe was cut to allow the slide gate to close. Need to contact owner to remove unauthorized pipe to comply with Title 23. (DWR UCIP - omagana)4/25/2016 5 inch pvc pipe running through crossing has been cut out to allow the slide gate to close. (DWR Sutter Yard - afreitag)4/20/2015 5inch pvc is still present blocking slide gate from closing. WS end of pipe has been exposed so there is no way to stop water from flowing through pipe during highwater times. (DWR Sutter Yard - afreitag)6/23/2014 Same as last inspection. There is no way to stop water from flowing through pipe during high water times. (DWR Sutter Yard - afreitag)12/17/2013 Same as last inspection. (DWR Sutter Yard - afreitag)7/18/2013 Same as last inspection. (DWR Sutter Yard - afreitag)10/19/2012 Unauthorized 5 inch PVC pipe running through 36 inch crossing. 5 inch PVC crossing prevents slide gate from closing during high water. Debris and sediment inside riser. This crossing was listed in the USACE Periodic Inspection as ID# USACE_CESPK_MA1C_2010_p_0258 for 5 inch PVC pipe running through culvert. (DWR UCIP - omagana) FIELD_STRUCT_DESC: 36-inch steel (not corrugated metal, as referenced in O&M manual) drainage pipe through the levee, approximately 14-16 feet below levee crown. Slide gate in corrugated metal pipe (CMP) riser on the waterside (WS) slope. Pipe also visible on the landside (LS). [Additional Reference(s): DWR Levee Log, 1992. USACE Sacramento O&M Manual 137, August 1955, (Station 331+31)]. FS Date: 10/27/2016 12:49:27 PM

CMP riser located on WS slope.

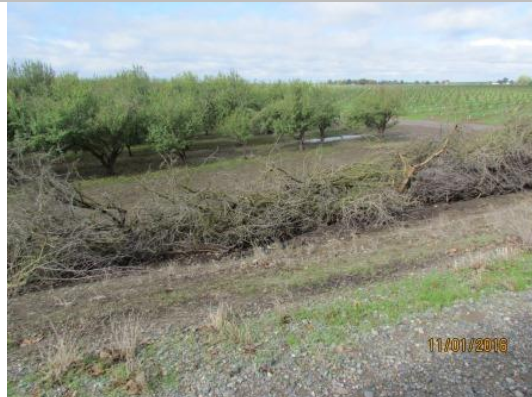
Photo 1 of 1 : FA_2016_MA0001_297_115_20161104_00173.jpg

LM Start	6.38	Rating **	M	Issue No.	115
LM End	6.38	Issue Type +	En	Location *	LS
Category	Earthen Levee			GPS Latitude/Longitude	
				Start	End
Item	Encroachments			39.281425 °	39.281425 °
				-122.022000 °	-122.022000 °
DWR ID	DWR_MA0001_01_f_2016_115				
Comment Code					
PR : Prunings					
Inspector Comment					
Remove prunings from the landside toe.

View of the prunings along the landside toe.

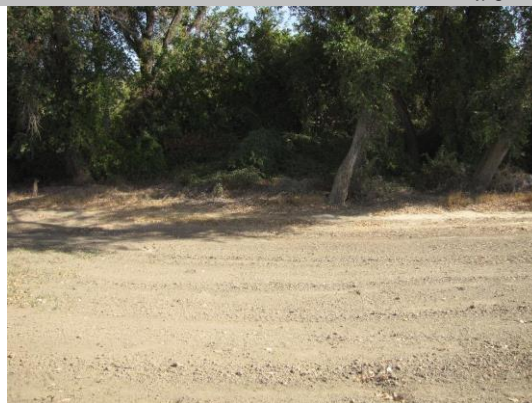
Photo 1 of 2 : UCIP_FA_2016_50486_70181.jpg

Comment Code					
Inspector Comment					
FS_ID:50486 DS_ID:16425 EP_NO: N/A Repair Type: Non-Urgent Crossing Status: Found UCIP Comments: 10/24/2016 Abandoned(DWR Sutter Yard-AFreitag)4/25/2016 Abandoned crossing.4/20/2015 Same as last inspection.6/23/2014 Same as last inspection.12/17/2013 Same as last inspection.7/18/2013 Same as last inspection.10/19/2012 Need to be properly abandoned concrete structure; plate covers concrete box; Concrete headwall damaged. This crossing was listed in the USACE Periodic Inspection as ID# USACE_CESPK_MA1C_2010_p_0262 for damage to concrete structure (vertical 2 inch wide cracks and spalling visible). FIELD_STRUCT_DESC: *ABANDONED* 72-inch corrugated metal (precast concrete) drainage pipe through the levee at an unknown depth below the crown. Structure is blocked on the waterside (WS) end with 3-foot concrete plug installed in 1980. Slide gate in concrete well on the landside (LS) shoulder. Concrete headwall at both toes. WS headwall not found. [Additional Reference(s): DWR Levee Log, 1992. USACE Sacramento O&M Manual 137, August 1955, (Station 339+74)]. FS Date: 10/27/2016 12:52:54 PM

View of WS no structure features visible.

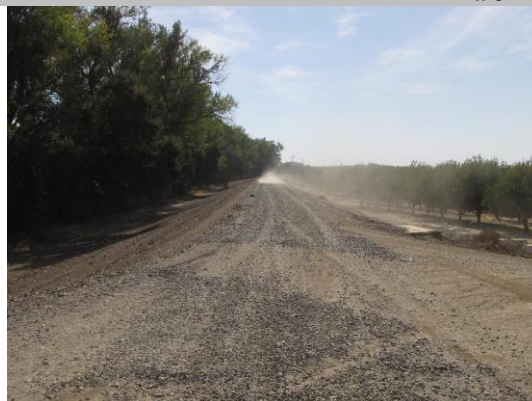
Photo 2 of 2 : UCIP_FA_2016_50486_70180.jpg

Item	DWR UCIP Field Study			39.281721 °	39.281721 °	
				-122.021894 °	-122.021894 °	
DWR ID						
Comment Code						
Inspector Comment						
FS_ID:50486 DS_ID:16425 EP_NO: N/A Repair Type: Non-Urgent Crossing Status: Found UCIP Comments: 10/24/2016 Abandoned(DWR Sutter Yard-AFreitag)4/25/2016 Abandoned crossing.4/20/2015 Same as last inspection.6/23/2014 Same as last inspection.12/17/2013 Same as last inspection.7/18/2013 Same as last inspection.10/19/2012 Need to be properly abandoned concrete structure; plate covers concrete box; Concrete headwall damaged. This crossing was listed in the USACE Periodic Inspection as ID# USACE_CESPK_MA1C_2010_p_0262 for damage to concrete structure (vertical 2 inch wide cracks and spalling visible). FIELD_STRUCT_DESC: *ABANDONED* 72-inch corrugated metal (precast concrete) drainage pipe through the levee at an unknown depth below the crown. Structure is blocked on the waterside (WS) end with 3-foot concrete plug installed in 1980. Slide gate in concrete well on the landside (LS) shoulder. Concrete headwall at both toes. WS headwall not found. [Additional Reference(s): DWR Levee Log, 1992. USACE Sacramento O&M Manual 137, August 1955, (Station 339+74)]. FS Date: 10/27/2016 12:52:54 PM

Overview of levee crown looking downstream at crossing.

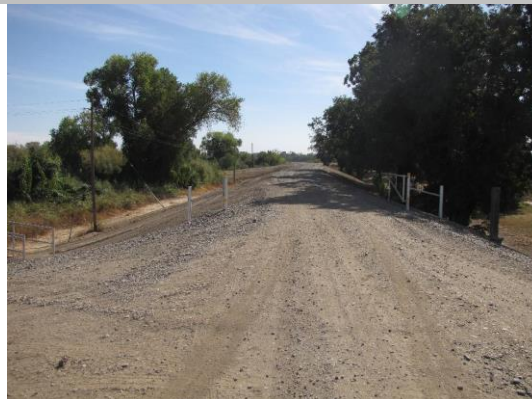
Photo 1 of 2 : UCIP_FA_2016_50487_70188.jpg

FS_ID:50487
DS_ID:16427
EP_NO: 9482
Repair Type: Non-Urgent
Crossing Status: Found
UCIP Comments: 10/24/2016 Abandoned.(DWR Sutter Yard-AFreitag)4/25/2016 Abandoned pipe. Needs to be properly plugged if it never gets used.4/20/2015 Same as last inspection. Structure is still buried.6/23/2014 Same as last inspection.12/17/2013 Same as last inspection.7/18/2013 Same as last inspection.10/19/2012 Structure is buried and non-operational. This crossing was listed in the USACE Periodic Inspection as ID# USACE_CESPK_MA1C_2010_p_0288 for sluice gate closed and backfilled on WS and full of sediment with wingwall cracked on LS. FIELD_STRUCT_DESC: *ABANDONED* 1 of 2: 36-inch reinforced concrete irrigation pipe through the levee at approximately 18 feet below the crown. Wooden slide gates on the waterside (WS) end. Sliding metal gate noted in O&M manual. Concrete headwalls located on both WS and landside (LS). O&M manual structure reference is 4'-9" x 9'-6" concrete box culvert. (Automatic Board Order (ABO) issued as Permit No. 9482, 1974 - Elizabeth M. Farnsworth) [Additional Reference(s): DWR Levee Log, 1992. USACE Sacramento O&M Manual 137, August 1955, (Station 370+90)].

Overview of levee crown looking downstream at crossing.

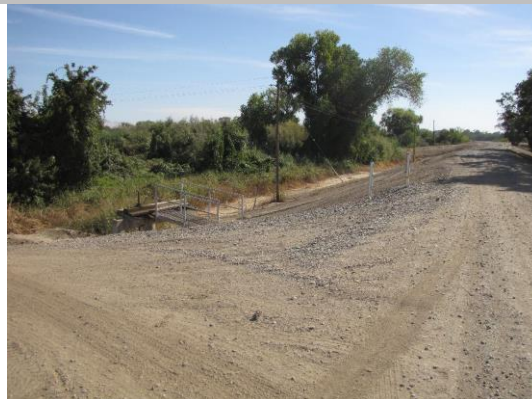
Photo 2 of 2 : UCIP_FA_2016_50487_70187.jpg

WS-walkway and concrete headwall.

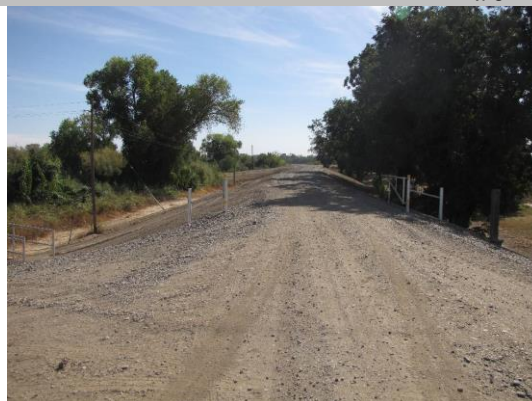
Photo 1 of 2 : UCIP_FA_2016_50488_70194.jpg

FS_ID:50488
DS_ID:17570
EP_NO: 9482
Repair Type: Non-Urgent
Crossing Status: Found
UCIP Comments: 10/24/2016 WS slide gate was unbruided and opened.(DWR Sutter Yard- AFreitag)4/25/2016 WS slide gate was unburied and opened allowing water to flow through to LS fields.4/20/2015 Structure is operational. WS slide gate was unbrried aloowing water to irrigate the fields. It gets reburried during highwater season. 6/23/2014 Same as last inspection. Soli dug out again and water flowing through crossing.12/17/2013 WS screw gate was closed and buried by soil again.7/18/2013 WS screw gate has been cleared of dirt and is open to irrigate LS fields. LS outlet is still mostly blocked by sediment.10/19/2012 Structure is buried and non-operational. This crossing was listed in the USACE Periodic Inspection as ID# USACE_CESPK_MA1C_2010_p_0288 for sluice gate closed and backfilled on WS and full of sediment with wingwall cracked on LS. FIELD_STRUCT_DESC: 2 of 2: 36-inch reinforced concrete irrigation pipe through the levee, approximately 18 feet below the crown. Wooden slide gates on the waterside (WS) end. Sliding metal gate noted in O&M manual. Concrete structure located on both WS and landside (LS). Inspector noticed that during 2015-2016 that this crossing is used in the spring and summer, and buried in the winter. O&M manual structure reference is 4'-9" x 9'-6" concrete box culvert. (Automatic Board Order (ABO) issued as Permit No. 9482-1974, Elizabeth M. Farnsworth) [Additional Reference(s): DWR Levee Log, 1992. USACE Sacramento O&M Manual 137, August 1955, (Station 370+90)].

Overview of levee crown looking downstream at crossing.

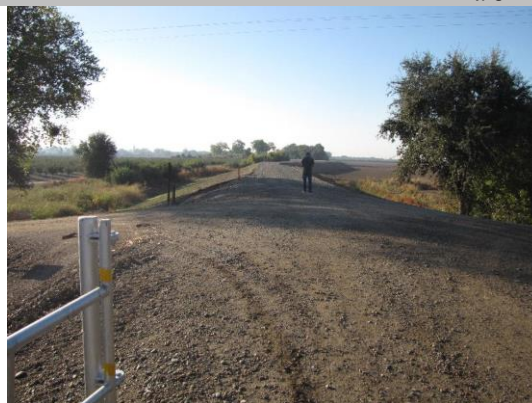
Photo 1 of 2 : UCIP_FA_2016_50489_70202.jpg

Comment Code					
Inspector Comment					
FS_ID:50489 DS_ID:16456 EP_NO: N/A Repair Type: Non-Urgent Crossing Status: Found UCIP Comments: 10/24/2016 Notes mentioned needing to confirm size of the culvert but was unable to access the ends at this inspection.(DWR Sutter Yard- A/Freitag)4/25/2016 Second slide gate was held open to allow water to flow through to the LS ditch.4/20/2015 Same as last inspection. Rebar pin was still inplace holding the gate opened.6/23/2014 Same as last inspection.12/17/2013 Same as last inspection.7/18/2013 Same as last inspection.10/30/2012 Sediment and debris on waterward and landward side. This crossing was listed in the USACE Periodic Inspection as ID# USACE_CESPK_MA1C_2010_p_0293 for wooden slide gate held open by a piece of rebar acting as a pin. FIELD_STRUCT_DESC: 60-inches by 72-inches (5-foot by 6-foot) reinforced concrete box irrigation culvert (O&M manual references 3-foot and 10-inch by 6-foot culvert) through the levee, approximately 12-15 feet below the crown. Two wooden slide gates on the waterside (WS) end. Concrete v-ditch along landside (LS) toe. [Additional Reference(s): DWR Levee Log, 1992. USACE Sacramento O&M Manual 137, August 1955, (Station 385+33.5)]. FS Date: 10/27/2016 12:59:31 PM

Overview of levee crown looking downstream at crossing.

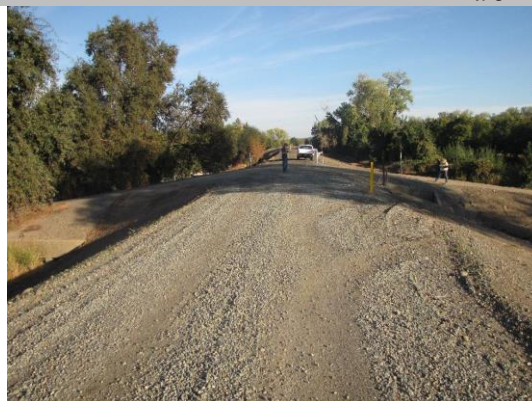
Photo 2 of 2 : UCIP_FA_2016_50489_70204.jpg

Item	DWR UCIP Field Study			39.294074 °	39.294074 °	
				-122.021435 °	-122.021435 °	
DWR ID						
Comment Code						
Inspector Comment						
FS_ID:50489 DS_ID:16456 EP_NO: N/A Repair Type: Non-Urgent Crossing Status: Found UCIP Comments: 10/24/2016 Notes mentioned needing to confirm size of the culvert but was unable to access the ends at this inspection.(DWR Sutter Yard- AFreitag)4/25/2016 Second slide gate was held open to allow water to flow through to the LS ditch.4/20/2015 Same as last inspection. Rebar pin was still inplace holding the gate opened.6/23/2014 Same as last inspection.12/17/2013 Same as last inspection.7/18/2013 Same as last inspection.10/30/2012 Sediment and debris on waterward and landward side. This crossing was listed in the USACE Periodic Inspection as ID# USACE_CESPK_MA1C_2010_p_0293 for wooden slide gate held open by a piece of rebar acting as a pin. FIELD_STRUCT_DESC: 60-inches by 72-inches (5-foot by 6-foot) reinforced concrete box irrigation culvert (O&M manual references 3-foot and 10-inch by 6-foot culvert) through the levee, approximately 12-15 feet below the crown. Two wooden slide gates on the waterside (WS) end. Concrete v-ditch along landside (LS) toe. [Additional Reference(s): DWR Levee Log, 1992. USACE Sacramento O&M Manual 137, August 1955, (Station 385+33.5)]. FS Date: 10/27/2016 12:59:31 PM

Overview of levee crown looking upstream at crossing.

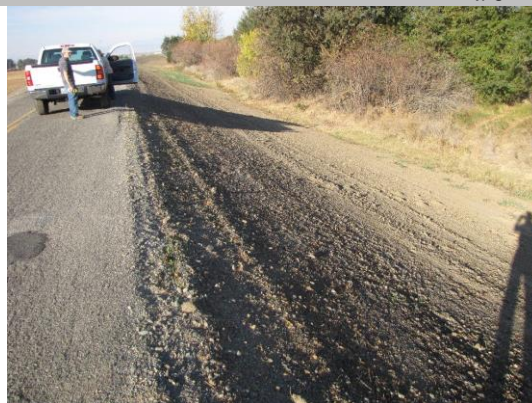
Photo 1 of 2 : UCIP_FA_2016_50490_70209.jpg

Comment Code					
Inspector Comment					
FS_ID:50490 DS_ID:16455 EP_NO: 12334 Repair Type: Non-Urgent Crossing Status: Found UCIP Comments: 10/24/2016 Pump removed from WS pipe. Pipe end left open and should be capped.(DWR Sutter Yard-AFreitag)4/25/2016 No LS inlet found4/20/2015 Same as last inspection.6/23/2014 Same as last inspection.12/17/2013 Same as last inspection.7/18/2013 Same as last inspection.10/30/2012 Siphon breaker housing unit is bent and has debris inside. LS outlet not found. FIELD_STRUCT_DESC: 10-inch asphalt coated steel irrigation pipe through the levee, 3 feet below the crown. Centrifugal pump on the waterside (WS) bank. Siphon breaker on the landside (LS) shoulder of the levee. (Permit No. 12334, 1978 - Jean James) [Additional Reference(s): DWR Levee Log, 1992]. FS Date: 10/27/2016 1:07:15 PM

View of WS-no features on levee shoulder or slope.

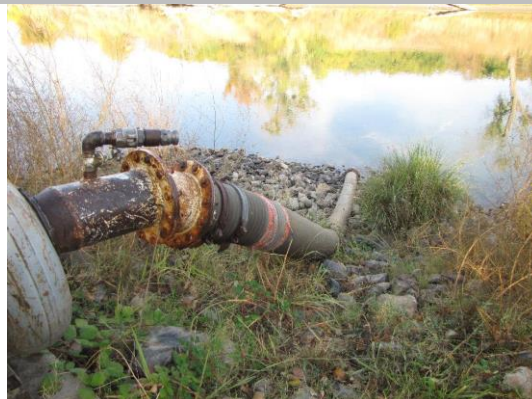
Photo 2 of 2 : UCIP_FA_2016_50490_70210.jpg

Item	DWR UCIP Field Study			39.297384 °	39.297384 °	
				-122.022989 °	-122.022989 °	
DWR ID						
Comment Code						
Inspector Comment						
FS_ID:50490 DS_ID:16455 EP_NO: 12334 Repair Type: Non-Urgent Crossing Status: Found UCIP Comments: 10/24/2016 Pump removed from WS pipe. Pipe end left open and should be capped.(DWR Sutter Yard-AFreitag)4/25/2016 No LS inlet found4/20/2015 Same as last inspection.6/23/2014 Same as last inspection.12/17/2013 Same as last inspection.7/18/2013 Same as last inspection.10/30/2012 Siphon breaker housing unit is bent and has debris inside. LS outlet not found. FIELD_STRUCT_DESC: 10-inch asphalt coated steel irrigation pipe through the levee, 3 feet below the crown. Centrifugal pump on the waterside (WS) bank. Siphon breaker on the landside (LS) shoulder of the levee. (Permit No. 12334, 1978 - Jean James) [Additional Reference(s): DWR Levee Log, 1992]. FS Date: 10/27/2016 1:07:15 PM

Pump located on WS bank.

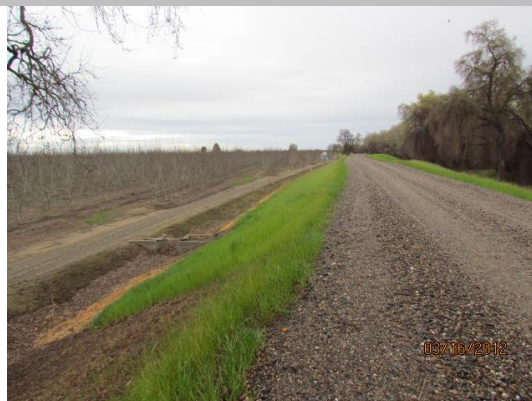
Photo 1 of 1 : FA_2016_MA0001_297_25_20160823_00011.jpg

LM Start	8.73	Rating **	M	Issue No.	25
LM End	9.19	Issue Type +	En	Location *	LS
Category	Earthen Levee			GPS Latitude/Longitude	
				Start	End
Item	Encroachments			39.308390 °	39.315125 °
				-122.031157 °	-122.030206 °
DWR ID	DWR_MA0001_01_s_2012_25				
Comment Code					
DT : Ditch					
Inspector Comment

View of the ag. ditch along the L/S toe.

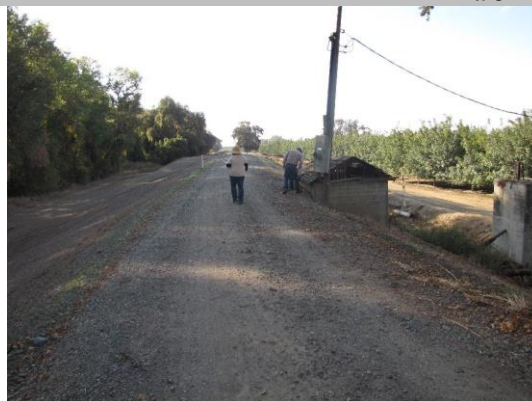
Photo 1 of 2 : UCIP_FA_2016_50491_70219.jpg

FS_ID:50491
DS_ID:16454
EP_NO: 9466
Repair Type: Non-Urgent
Crossing Status: Found
UCIP Comments: 10/24/2016 Abandoned.(DWR Sutter Yard-AFreitag)4/25/2016 Crossing appears to be abandoned. Power lines cut from the panels inside the concrete structure on LS.4/20/2015 Same as last inspection.6/23/2014 Same as last inspection.12/17/2013 Same as last inspection.7/18/2013 Same as last inspection.10/30/2012 No access to inspect slide gate on LS. Roof of pumping house deteriorating and debris scattered on LS. WS crossing not found. This crossing was listed in the USACE Periodic Inspection as ID# USACE_CESPK_MA1C_2010_p_345 no issues recorded.
FIELD_STRUCT_DESC: *ABANDONED* 24-inch steel irrigation pipe through the levee, approximately 8-10 feet below the crown. Slide gate in concrete riser on the landside (LS) slope. Pump house encroaches into the LS slope. Two service poles on the LS shoulder. No visible appurtenances found on the waterside (WS) toe. Power source cut on the LS. (Automatic Board Order (ABO) issued as Permit No. 9466, 1974 - Roman Catholic Bishop of Sacramento). [Additional Reference(s): DWR Levee Log, 1992].

Overview of levee crown looking downstream at crossing.

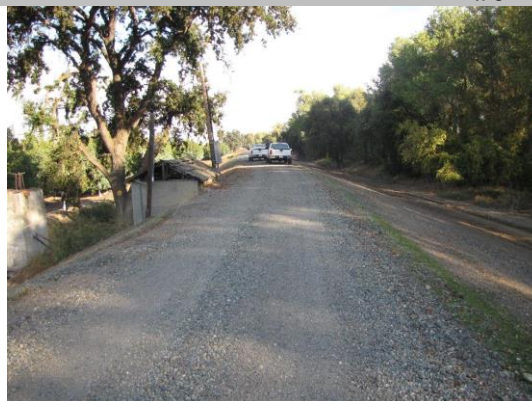
Photo 2 of 2 : UCIP_FA_2016_50491_70217.jpg

Overview of levee crown looking upstream at crossing.

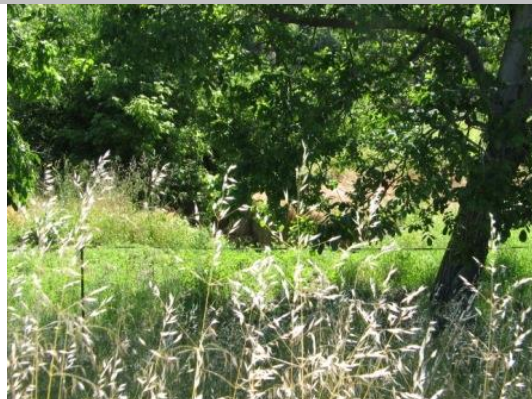
Photo 1 of 1 : FA_2016_MA0001_297_18_20160823_00009.jpg

LM Start	10.13	Rating **	M	Issue No.	18
LM End	10.13	Issue Type +	Ma	Location *	WS
Category	Earthen Levee			GPS Latitude/Longitude	
				Start	End
Item	Erosion / Bank Caving			39.328697 °	39.328697 °
				-122.029262 °	-122.029262 °
DWR ID	DWR_MA0001_01_s_2012_18				
Comment Code					
E1 : Note and monitor erosion site.					
Inspector Comment					
Monitor the erosion site.

View of the erosion along the waterside of the levee.

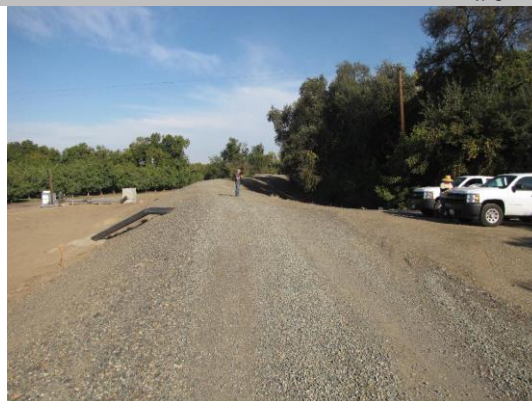
Photo 1 of 2 : UCIP_FA_2016_50494_70246.jpg

Comment Code					
Inspector Comment					
FS_ID:50494 DS_ID:16453 EP_NO: N/A Repair Type: Urgent Crossing Status: Found UCIP Comments: 10/24/2016 Ws erosion still present. Looks to be just from rain run off.(DWR Sutter Yard- AFreitag)4/25/2016 Erosion still present by the WS pipes. (DWR Sutter Yard - afreitag)4/20/2015 Erosion happening near WS shoulder where the pipes enter the levee. May just be caused by rain runoff. (DWR Sutter Yard - afreitag)6/23/2014 Same as last inspection. (DWR Sutter Yard - afreitag)12/17/2013 Same as last inspection. (DWR Sutter Yard - afreitag)7/18/2013 Same as last inspection. (DWR Sutter Yard - afreitag)10/30/2012 Landward side has been completely altered. Need to find permit for new work. (DWR UCIP - omagana) FIELD_STRUCT_DESC: 24-inch steel pipe through the levee, approximately 15-20 feet below the crown. Gate valve on the waterside (WS) end. Dual 14-inch line visible on the landside (LS). Unable to determine if this is the same crossing as DS_ID 17656. [Additional Reference(s): DWR Levee Log, 1992. USACE Sacramento O&M Manual 137, August 1955, (Station 538+42)]. FS Date: 10/27/2016 1:14:36 PM

Overview of levee crown looking upstream at multiple crossings.
